VERIFICATION REQUIREMENTS FOR COVER SYSTEMS

Technical Guidance for
Developers,
Landowners and
Consultants

**Yorkshire and Lincolnshire
Pollution Advisory Group**

Version 4.1 – June 2021

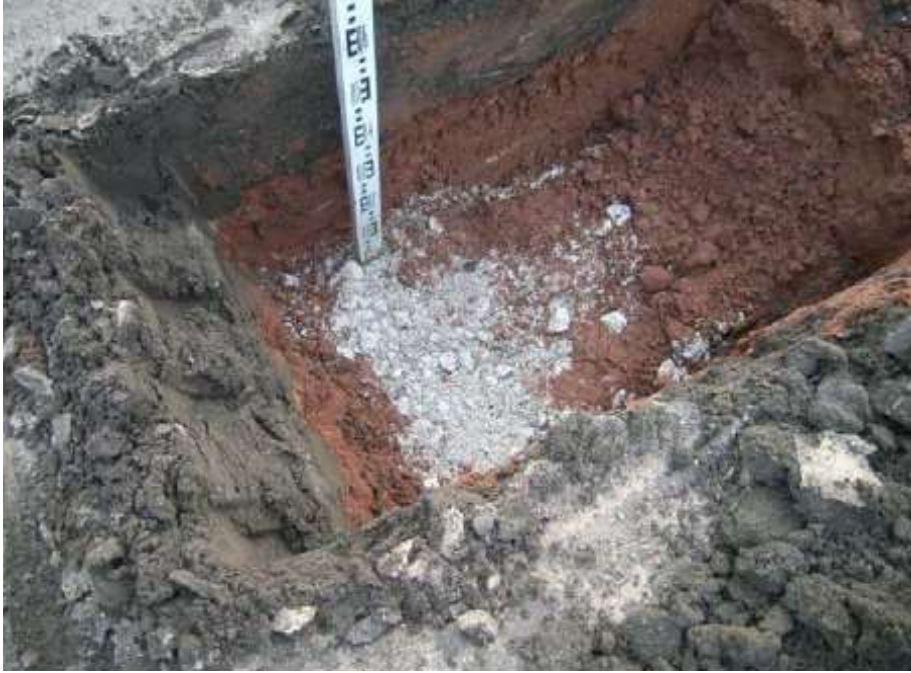
Photograph 8: Excavation within public open space and verification pit showing the presence of a remediation break layer at the base, a crushed sandstone inert fill overlain by topsoil.

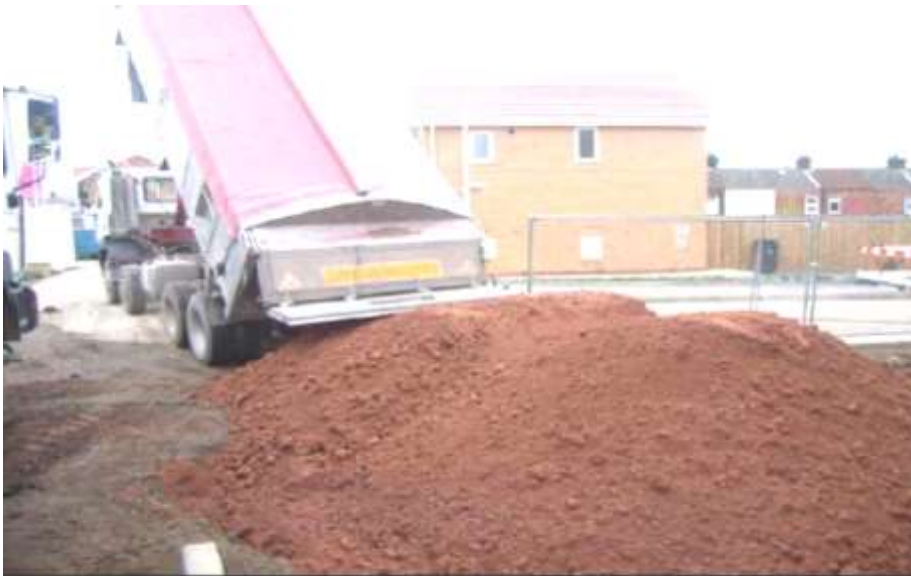
Photograph 9: Inert crushed sandstone being delivered. The spatial area of the remediation can be observed from these photographs (old terrace housing).

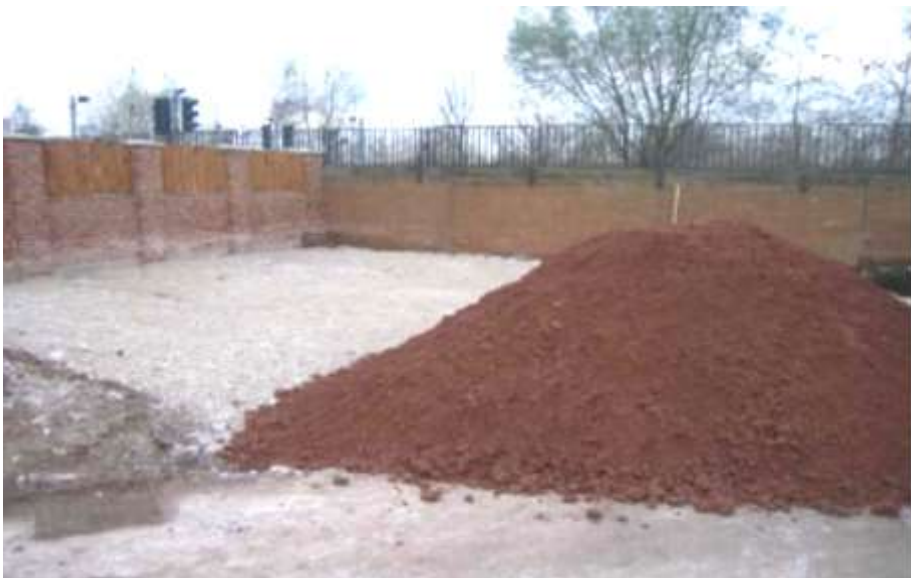
Photograph 10: Inert crushed sandstone being delivered with visible remediation break layer. The spatial area of the remediation can be observed from these photographs (traffic lights).
